Problems of preserving and restoring Baroque heritage: the church in Dubrovo and the monastery in Boruny

ABSTRACT:

Baroque architecture; spatial and compositional principles of construction; restoration of religious objects

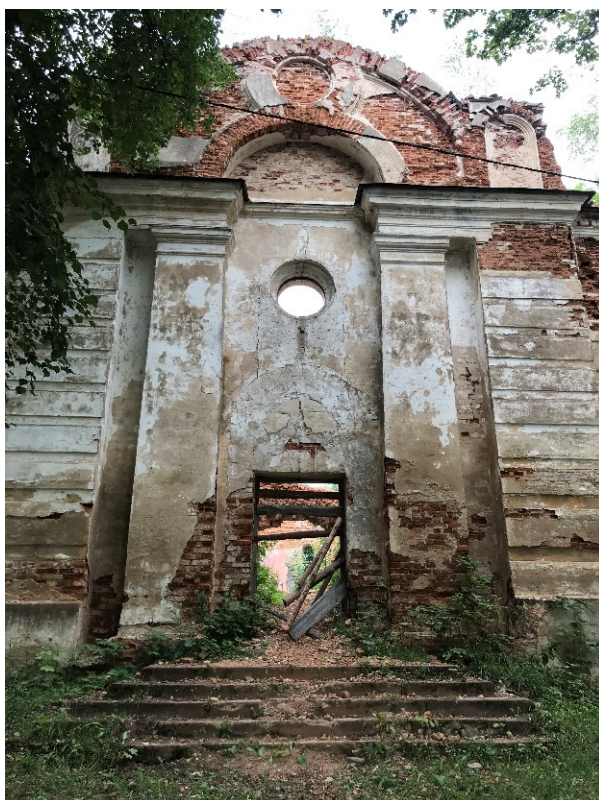
The main facade was horizontally three-part with a central part protruding the length of the brick and ended with a semi-circular pediment (Fig. 1). The tympanum of the pediment along the vertical axis is decorated with a semicircular decorative niche, and above it is a round niche. The pediment retains decoration in the form of finely profiled flat niches with a circular pattern made using the sgraffito technique. Above the entrance, there is a circular shape (not preserved, only a trace remains on the wall), framed by pilasters of the Doric order, there is a round window along the central axis. There are no other windows on the main facade. The main facade up to the profiled cornice is decorated with wide protruding stripes that do not affect the Doric pilasters. The side facades are decorated with six arcaded windows called biforium; each facade has three such windows (Fig. 2).

Fig. 1. Church of the Ascension of the Virgin Mary in Dubrovo. The main facade of the church (photo by N. Kalasoškaja)

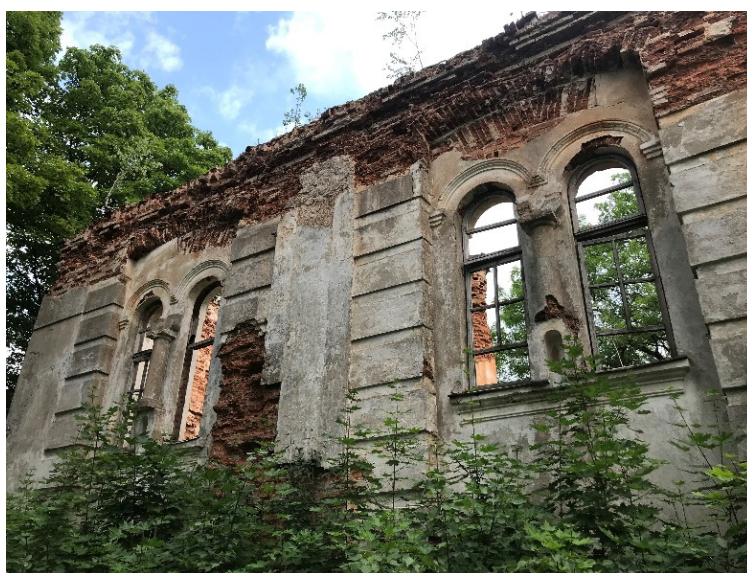
Fig. 2. Church of the Assumption of the Virgin Mary in Dubrovo. Fragment of the facade (photo by N. Kalasoškaja)

The window consists of two openings of a semicircular outline, separated by a column with a faceted capital and placed in a niche with a semicircular outline.

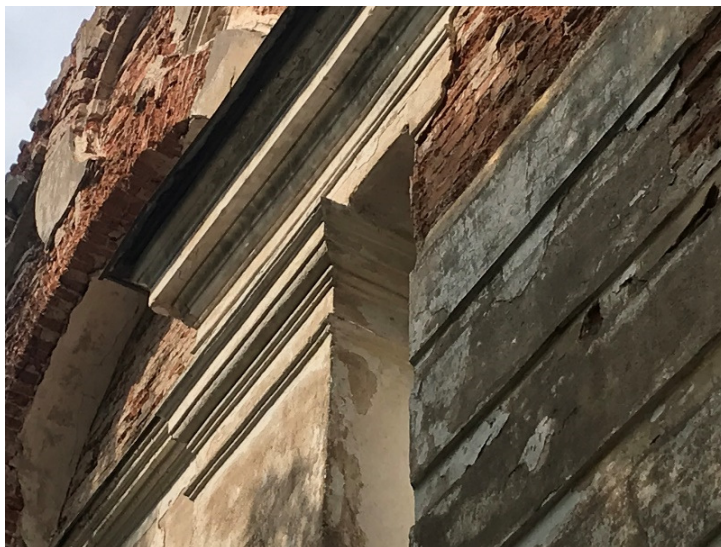
The side facades, in the part corresponding to the narthex in the interior, contain window openings: round, above – rectangular with a semi-circular seal. The ends of the openings are decorated with a finely profiled double cornice with an arched outline. On the side facades, the decoration of the window partitions in the form of wide longitudinal stripes has been preserved (Fig. 3).

Fig. 3. Church of the Assumption of the Virgin Mary in Dubrovo. Fragment of the side facade (photo by N. Kalasoŭskaja)

In the apse section, flat niches and openings with a circular finish were preserved; there was also a round window, which is now bricked up, but the lattice has been preserved. The church was built of brick, some of the plaster has been preserved. On fragments of walls where masonry was exposed, it is clear that some openings were modified or blocked (Fig. 3).

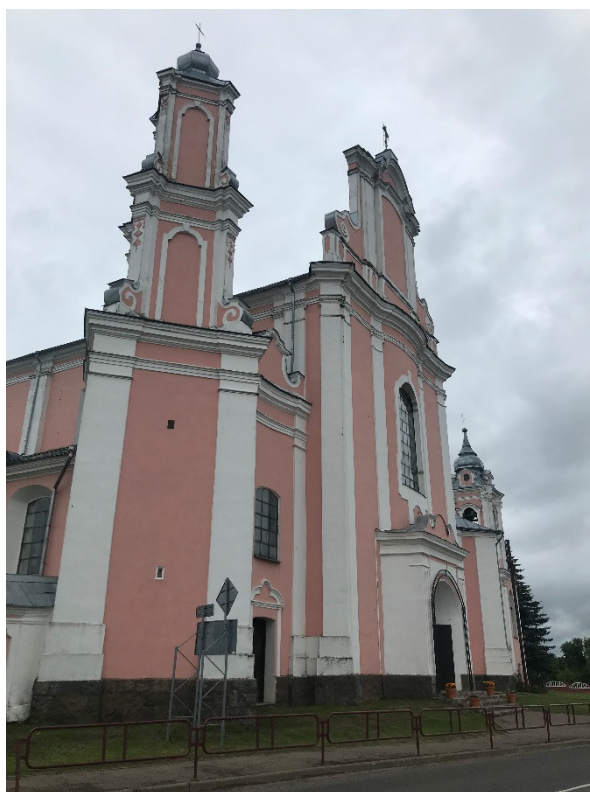
117 kilometers from Minsk is the town of Boruny, famous for the Church of the Holy Apostles Peter and Paul, which is located there (Fig. 4). The church building, in its existing form, is from the end of the 18th century, when in 1747-1753 it was built according to the design of the architect Alexander Asikevich. The church was built in the Baroque style. The church is a three-nave basilica with a long altar apse and two symmetrical chapels.

Fig. 4. Church of the Holy Apostles Peter and Paul in Boruny.
Main facade (photo by N. Kalasoškaja)

The facade of the church is asymmetrical with a complex outline and is adjacent to a multi-tiered tower. The tower is not placed in line with the facade. The central nave of the church has a risalit on the facade and is completed with an attic pediment. The facade planes have a curvature, which is accentuated by a wide profiled cornice. The decor uses stylized volutes.

The use of two-color plaster made it possible to highlight the decor in white against the background of pinkish-terracotta walls: pilasters, cornices, window frames. The interior has a cylindrical vault in the central nave, and cross vaults in the side naves. The interior decor has features of the Rococo style. Under the church there is a crypt-burial vault. The church is currently operational.

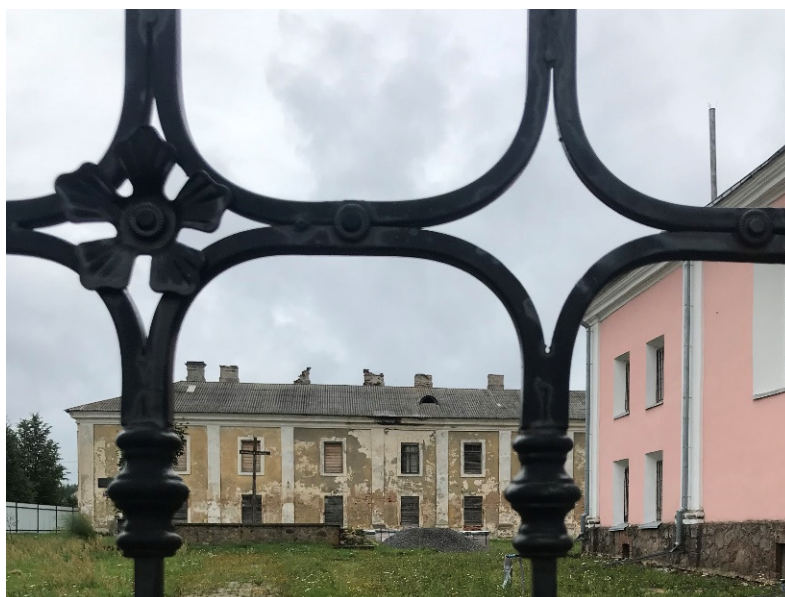
The monastery building was built in 1778-1793. The monastery building is not functioning. The building is two-story and has a T-shaped layout. The facades are rhythmically divided by rectangular window openings, decorated with pilasters with bases, but without capitals. The building is surrounded by a profile cornice. The premises are covered with cylindrical vaults (Fig. 5).

Fig. 5. The facade of the monastery building and a fragment of the facade of the Church of the Holy Apostles Peter and Paul in Boruny (photo by N. Kalasoŭskaja)

The church and monastery occupy a block in the development of a small settlement. The church is operational, but the monastery building is not in use today and requires repairs.
