Application of ultrasonic testing for the quantitative assessment of wood element degradation

ABSTRACT:

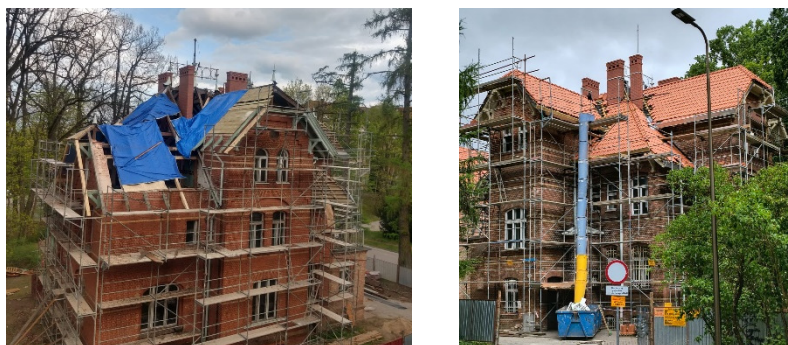
Fig. 2. View of a 19th-century historical building during revitalization works

The study involved fragments of pine floor beams originating from a 19th-century residential building (Fig. 2). Samples were collected during the revitalization of a historic townhouse. The elements exhibited advanced biological degradation typical of brown rot associated with high moisture content.

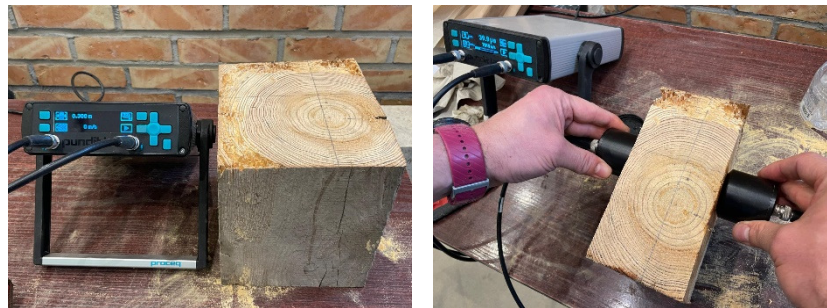
Fig. 4. Measurements on the samples

Measurements were carried out using a Pundit Lab+ Ultrasonic Instrument. The unit consisted of a pair of wave transducers (transmitter and receiver) and a terminal/display station with data acquisition and Pundit Link software for data visualization and analysis. Testing was performed in a through-transmission setup, with the transducers placed on opposite sides of the sample, recording the travel time of the wave between the transmitting and receiving probes (Fig. 4).

This measurement configuration minimizes the contribution of surface waves and ensures maximum sensitivity to changes in the internal structure of the material. To ensure stable acoustic coupling between the probes and the wood surface, coupling gel was applied.
