Thermal cracks of large area insulating glasses

5. Assessment of the causes of broken glazing in the Municipal Art Gallery building in Częstochowa

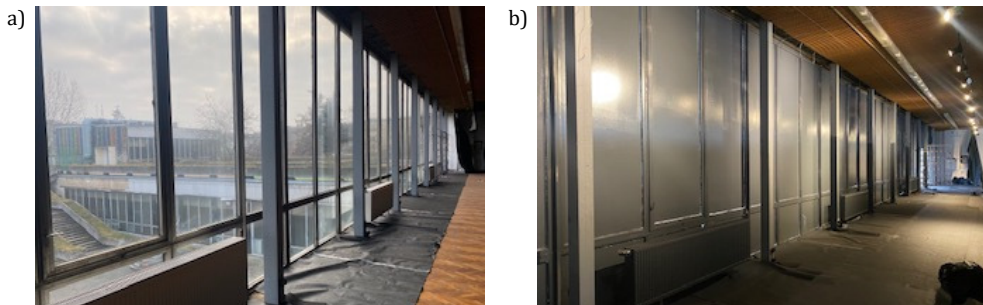
a)   b)

Fig. 2. Windows in the exhibition hall: a) before renovation, b) after renovation

On the first floor of the building is the largest hall of 480 m², which for a number of years was not used during June and August due to the temperatures exceeding 30°C, making it impossible to use as an exhibition hall (Fig. 2a). A refurbishment of the hall was carried out in 2022 to save on heat loss in winter and to insulate the hall from solar heating in the summer. The refurbishment work included painting the showcases with two-component epoxy paint using the spray method and insulating the showcases with thermal insulation matting on an independent wooden frame (Fig. 2b).
